Phosphate Plant – Oil Tank

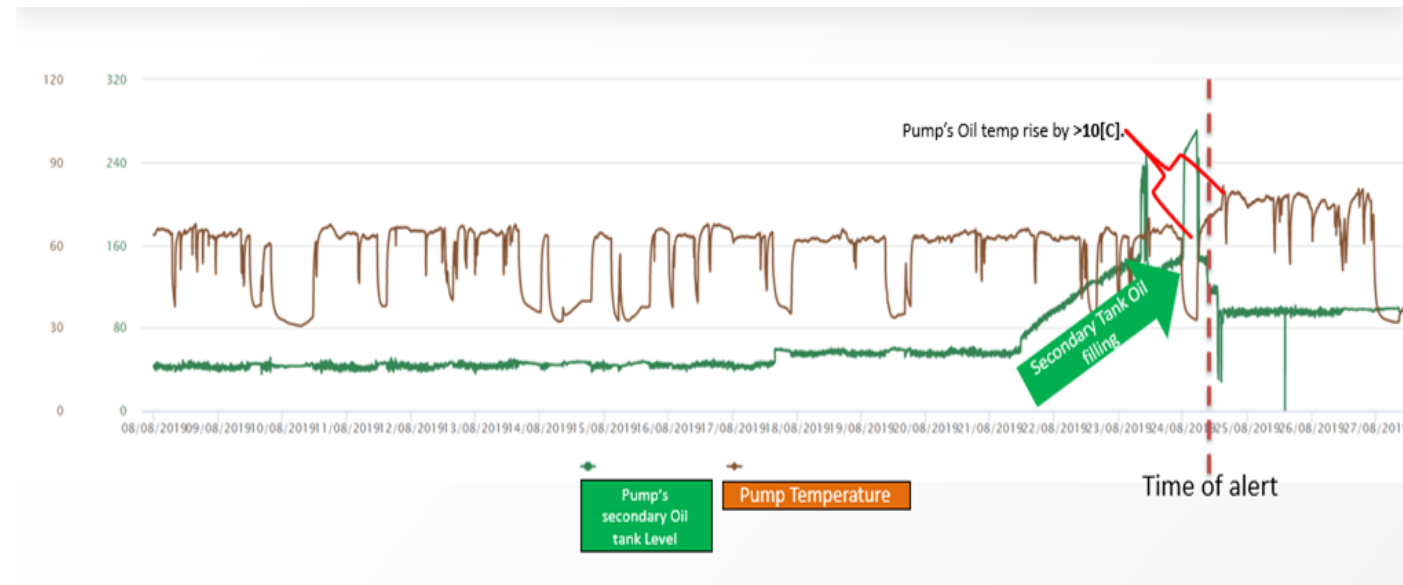
- The pump's oil temperature rose by $>10^{\circ}\text{C}$. This temperature level is not standard. Such high values have never been measured in the history of the sensor.
- This rise in temperature was observed after filling the secondary oil tank, due to filling it with excessive amounts of oil. This made it impossible for oil to flow from the pump's bearing back into the oil reservoir, which would have damaged the bearing and the pump as a result.

- SAM GUARD triggered an alert presenting the engineer investigating the issue with a unique insight.
- SAM GUARD provided both oil reservoir level and oil temperature, and the relation between the two that triggered the alert. This enabled the plant engineer to immediately understand the problem.
