Phosphate Plant – Pump

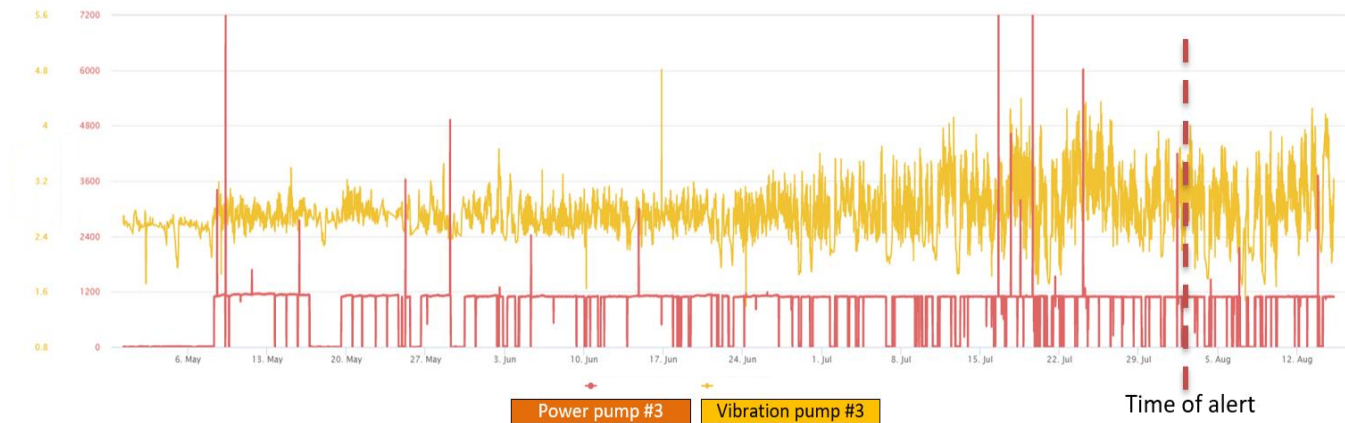
- The pump was experiencing vibration drift:
- There was an observable change in the behavior of pump #3's vibration tag.
- The rise in vibration magnitude and range started ~06/07/19.

Pump Vibration drift over time

- SAM GUARD alerted about changes in vibration behavior while the pump's power remained in baseline.
- This indicated that the issue was not related to higher performance by the pump, because performance remained the same (flow/RPM wise) while the vibration was increasing and becoming unstable.
- SAMGUARD detected a deviation from standard tag behavior in reference to other parameters related to equipment.
- Alerts led the engineer to suspect a problem with the pump's impeller or in the pump's fixation to the concrete structure below. The issue was verified via an external vibration measurement device, and a problem was isolated in pump #3.
- The maintenance engineer found that the pump was showing signs of imbalance and suspected that it had material crystallization on the pump impeller. The decision was made to stop the pump for cleaning.
